Koman Dam Albania - Hydraulic model tests for spillways and plunge pool (2008)

Milad Daneshvari, Giovanni De Cesare

Client: Pöyry Ltd, Zürich

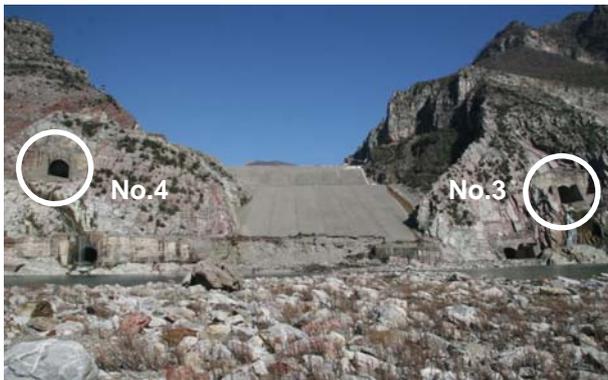
Figure 1 : View of the downstream face of the Koman dam with eroded dam toe and the outlet works

From the dynamic pressure measurement at the dam toe with different scenarios it can be concluded that one of the principal reasons of dam toe erosion at Koman dam is the waves with 1 to 3 meters amplitude which hit the dam body every 5 seconds.

Finally, when considering the rehabilitation of the dam toe, the new structure must be able to withstand over longer periods as well as with frequent impacts of high flow velocities and strong wave actions. In this sense a permeable material with a proper protecting structure such as a high resistant rip-rap against wave action seems compulsory. Regarding the right bank peninsula separating the plunge pool from the powerhouse tailrace channel, a tailored solution to withstand high velocity water flow must be considered.

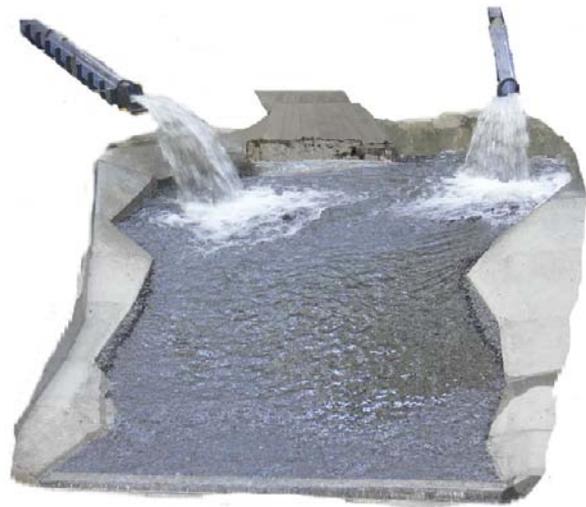
Figure 2 : Front view as a photomontage of the physical model and damaged dam toe
